**NASA  
Reference  
Publication  
1291**

# Fractography Handbook of Spaceflight Metals

Rebecca J. Derro

Rebecca J. Derro  
*Goddard Space Flight Center*  
*Greenbelt, Maryland*

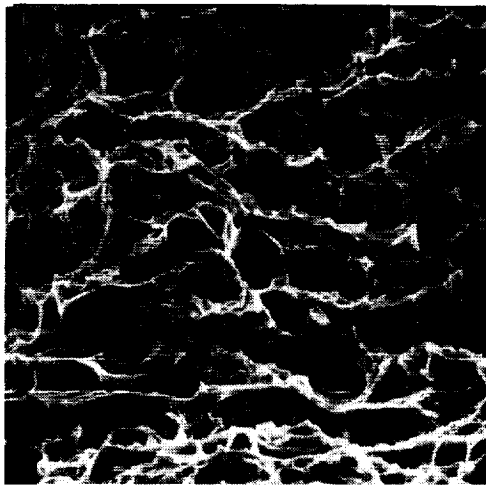
Fig 2-15 640X  
Region B. The central area of  
Fig. 2-14.

Figures 2-14 and 2-16 Area B: The dimples appear larger in the central zone of the fracture than on the shear lip. There are more features such as steps and small ridges here.

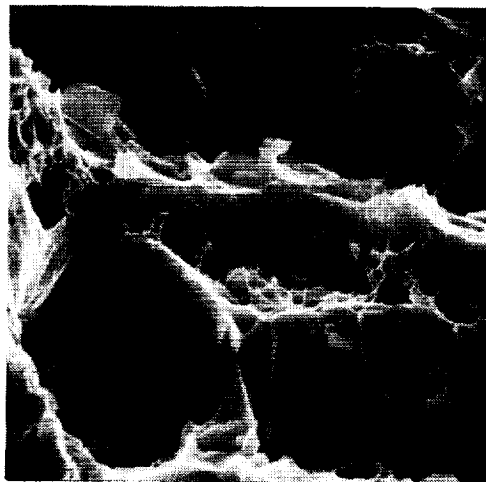
Fig 2-16 2500X.  
Region B. Small ductile dimples.

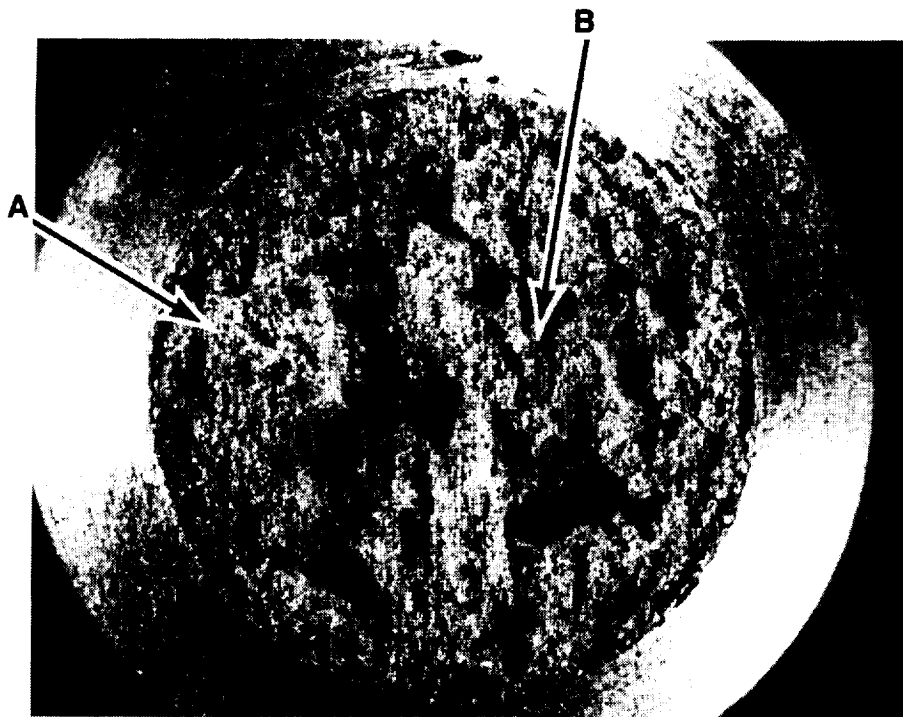
Fig 2-17  
Photomicrograph.

The overall appearance of this fracture surface as seen in Figure 2-17 is coarse and grainy. Area A depicts an area near the edge and area B depicts an area in the central region.

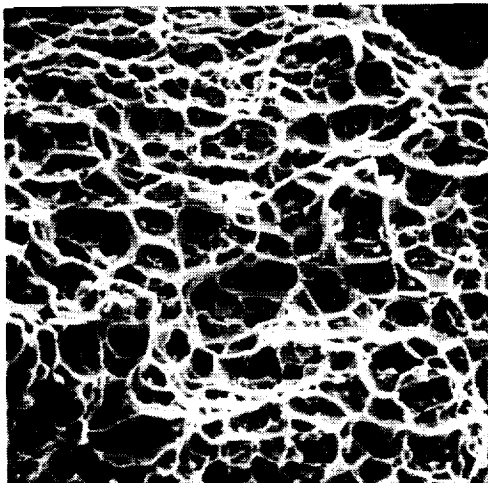
Fig 2-18 320X.  
Region A. Central region of fracture.

Figures 2-18 to 2-20 Area A: There are numerous ductile dimples. Note the very small dimples at 2500X in Figure 2-20.

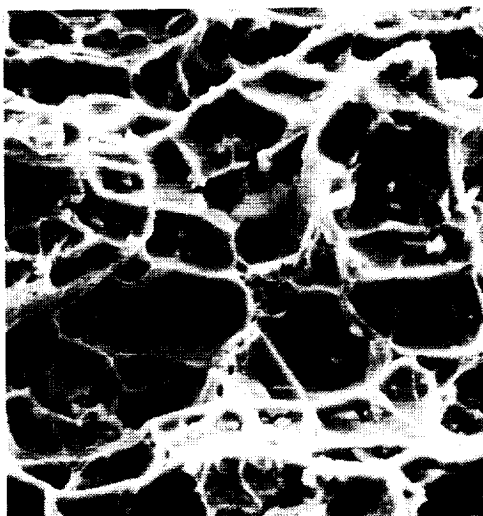
Fig 2-19 640X.  
Region A. Unusual shape of dimples  
in central region.

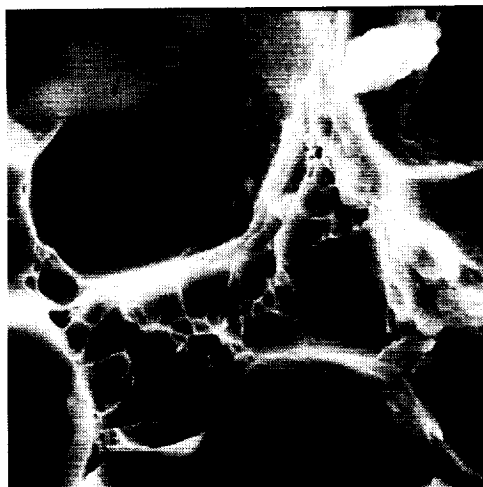
Fig 2-20 2500X.  
Region A. Lower center of Fig. 2-19.

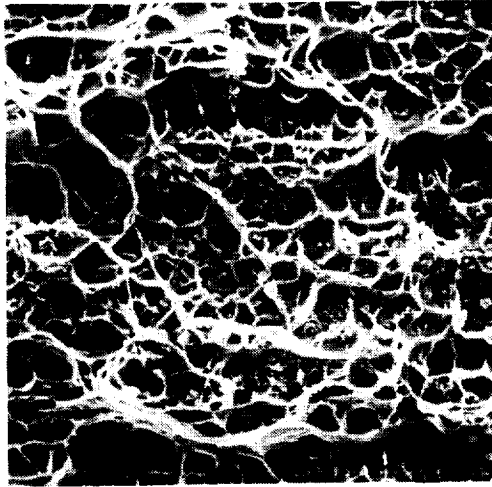
Fig 2-21 320X.  
Region B. Area near the notch.

Figures 2-21 to 2-23 Area B: This area looks similar to A but notice the shape of the ductile ridges. The unusual shape is due to parallel rows of inclusions. Microductility is also seen here.

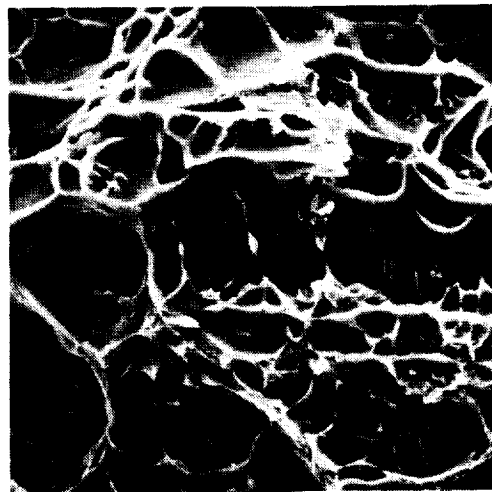
Fig 2-22 640X  
Region B. Enlarged view of Fig. 2-21.

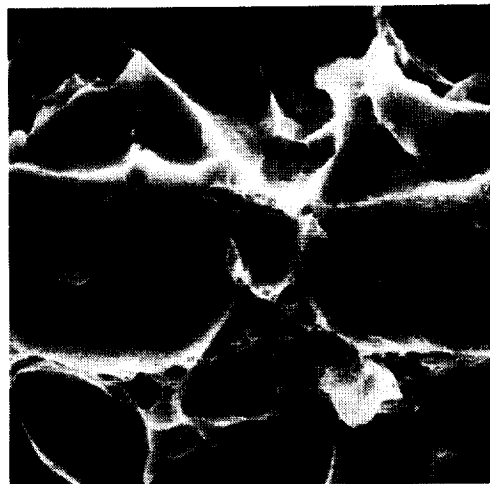
Fig 2-23 2500X  
Region B. Microdimples in the shear  
lip zone.

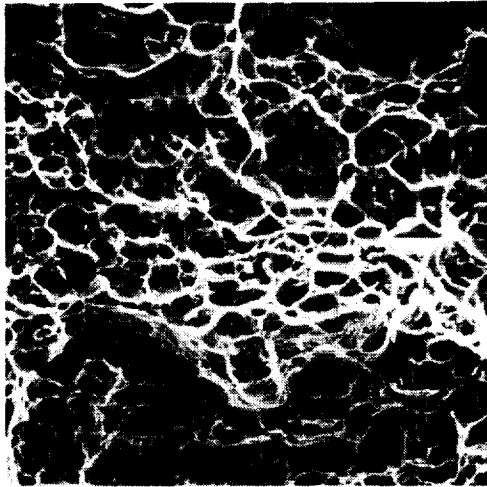
Fig 2-25 320X  
Region A. Central region.

Figures 2-25 to 2-30: Fractographs from various areas show the similarity of this sample to the notched sample at room temperature. The cold temperature did not change the appearance of the fracture.

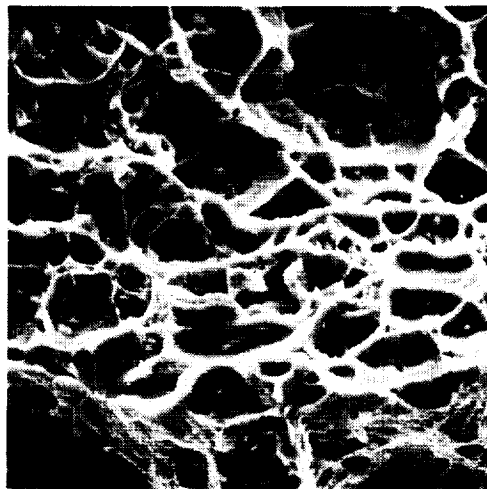
Fig 2-26 640X  
Region A. Central region.

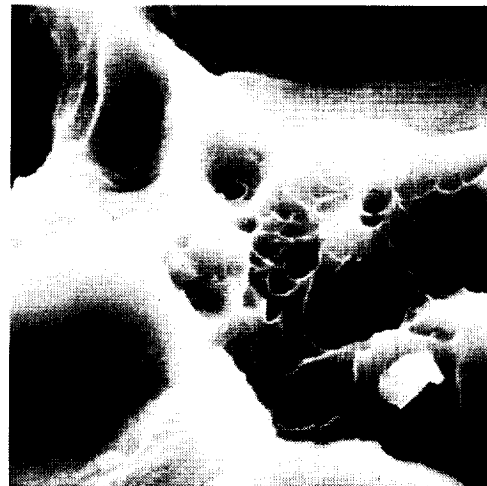
Fig 2-27 5000X  
Region A. Central region.

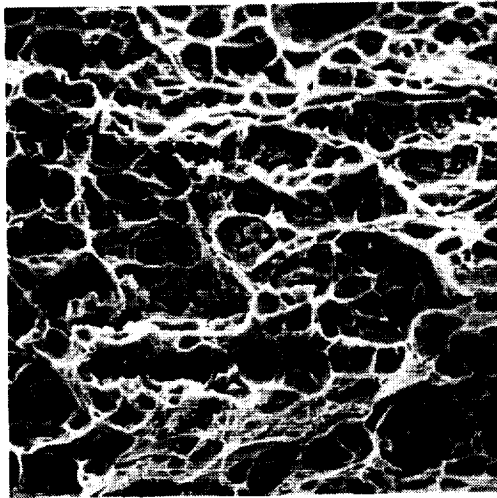
Fig 2-28 320X  
Region A. Another area near the center.

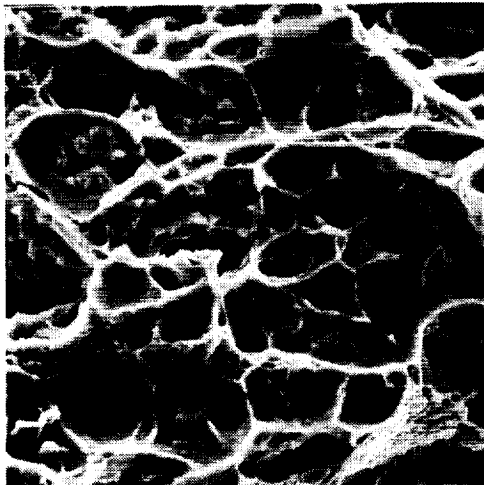
Fig 2-29 640X.  
Region A. Same area as in Fig. 2-28.

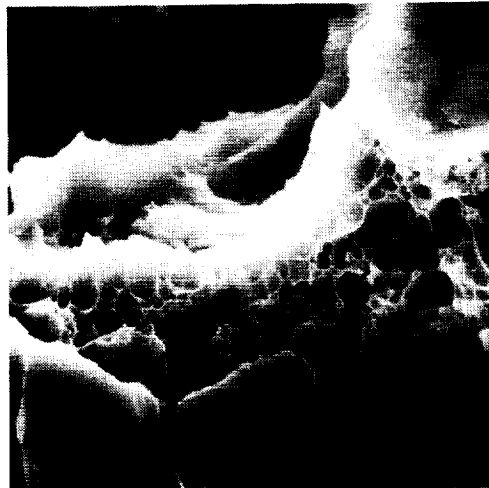
Fig 2-30 2500X.  
Region A. Same area as in Fig. 2-29.

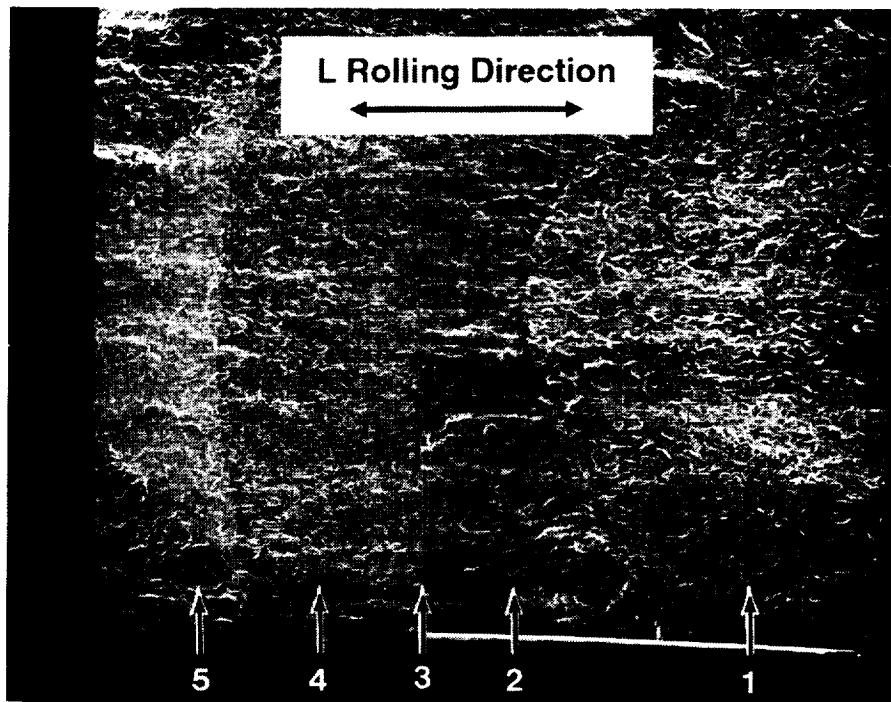
Fig. 2-31  
SEM photomicrograph of fracture surface.

Five distinct regions are identified in the optical photograph in Figure 2-31. Region 1 is the pre-crack region and region 5 is the fast fracture region. Regions 2, 3 and 4 were documented using the SEM fractographs. The loading data for these regions is displayed in the following chart.

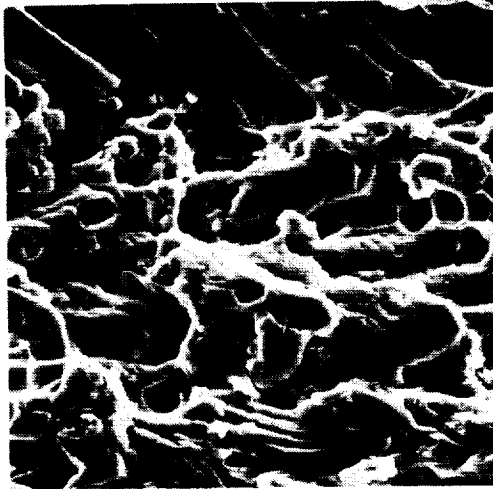
Fig. 2-32 640X  
Region 2. Faint fatigue striations.

Figures 2-32 to 2-34 Region 2: The striations are faint at this low load ratio.

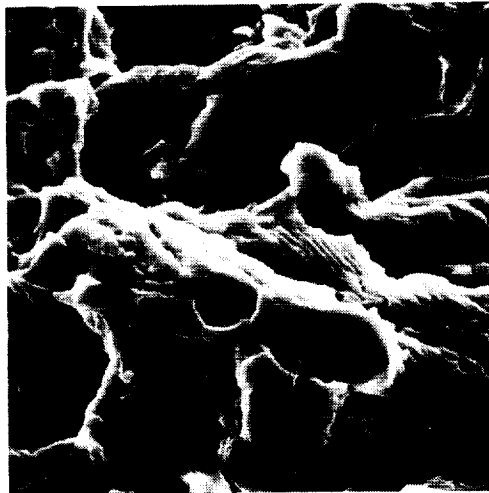
Fig. 2-33 1250X  
Region 2.

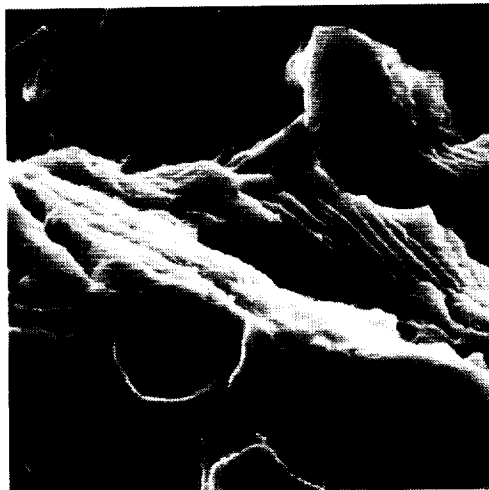
Fig. 2-34 2500X  
Region 2.

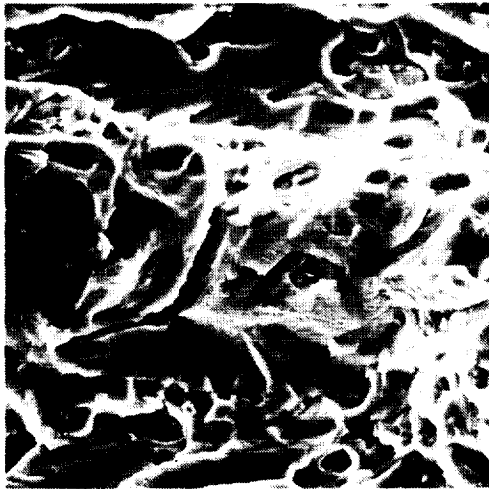
Fig. 2-35 640X  
Region 3. Fatigue striations.

Figures 2-35 to 2-37 Region 3: The fatigue striations are much more defined at this load.

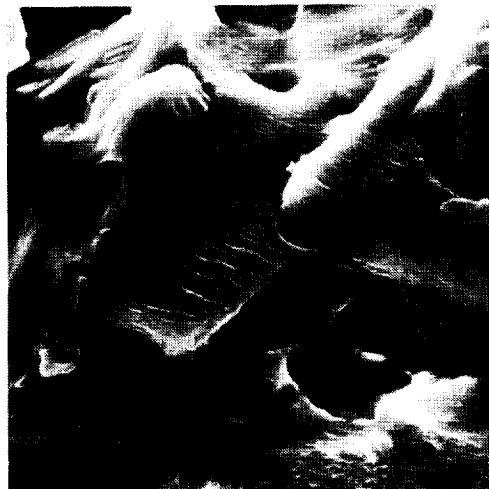
Fig. 2-36 2500X  
Region 3.

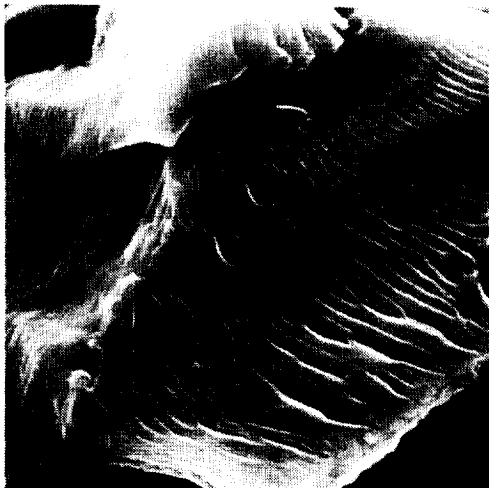
Fig. 2-37 5000X  
Region 3.

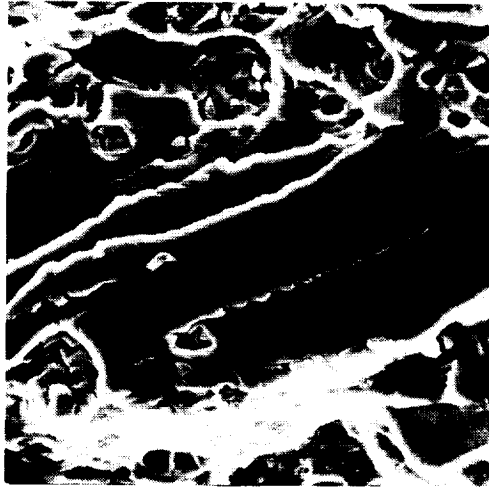
Fig. 2-38 640X  
Region 4. Fatigue striations.

Figures 2-38 to 2-40 Region 4: Note that the striation spacing is even larger at the smallest R value.

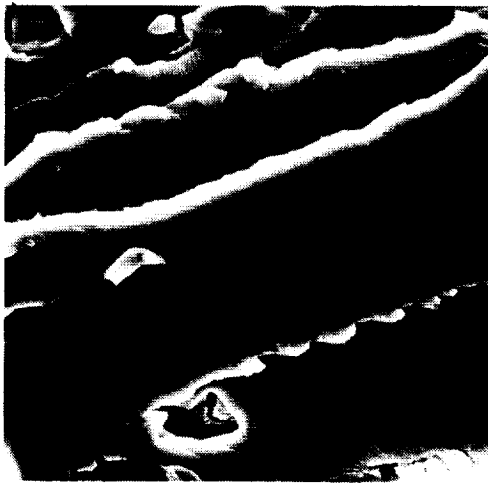
Fig. 2-39 1250X  
Region 5.

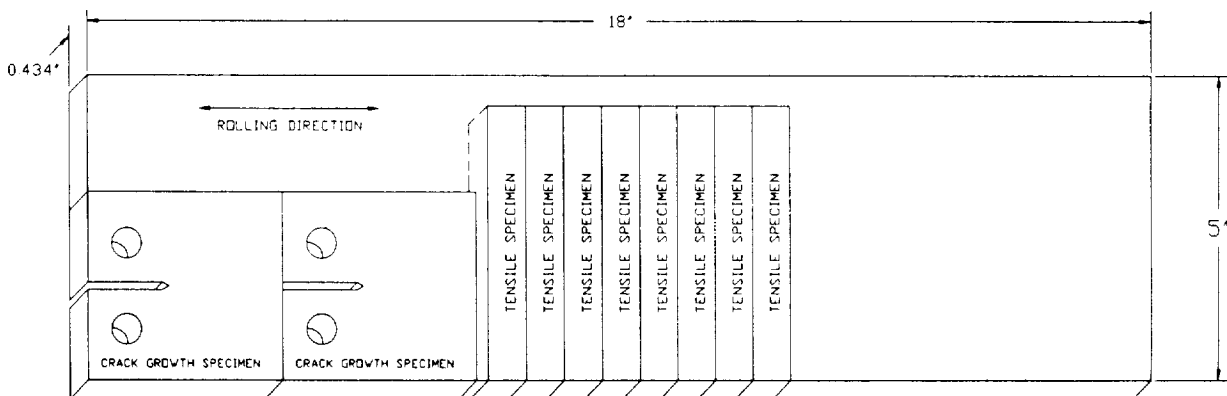
**Figure 3-a. Pattern used to cut test specimens**

Mill annealed ELI plate. Heat treatment: As received annealed. Hardness: HRC 32. Dimensions: 0.434" Tk X 5" W X 18" L. Test specimens were cut from the plate according to the diagram in Figure 3-a.

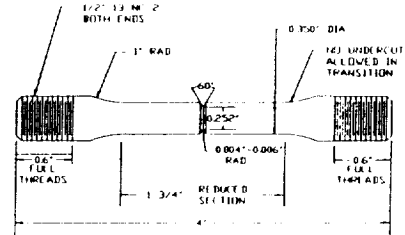
Figure 3-c. Notched tensile overload specimen, 4 in long, 0.004-0.006" root radius, 0.20" notch diameter.

Smooth tensile overload specimen dimensions are shown in Figure 3-b. Notched tensile overload specimen dimensions are shown in Figure 3-c. Compact tension specimens were made according to Figure 3-d.

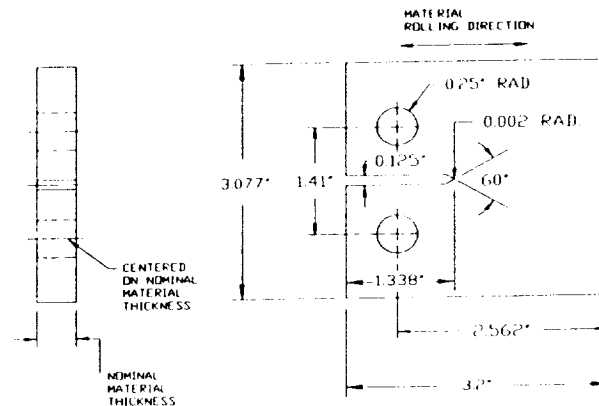
Figure 3-d. Compact tension specimen

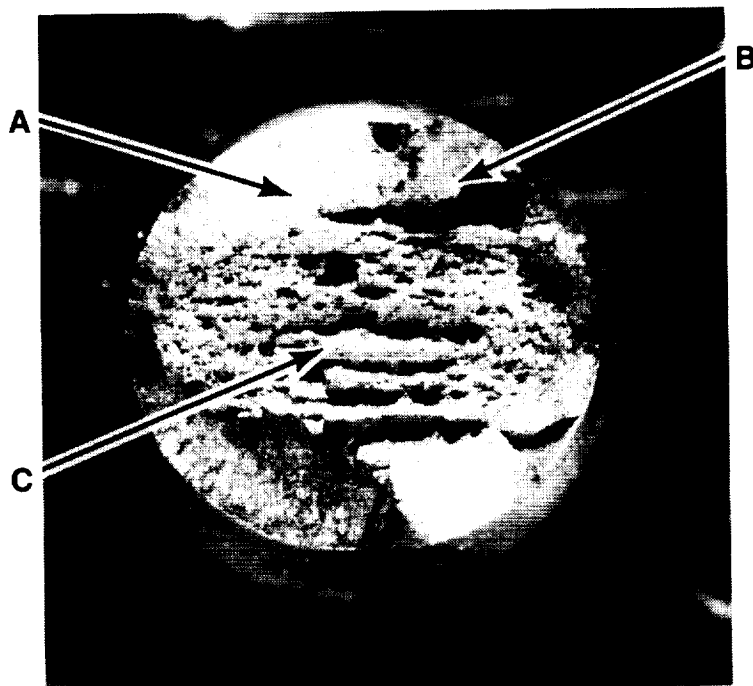
Fig 3-3

Optical photomicrograph of fracture surface

The surface of this fracture is rough and has many distinct ridges as seen in Figure 3-3. The ridges are associated with the elongated grain structure and the hot working process.

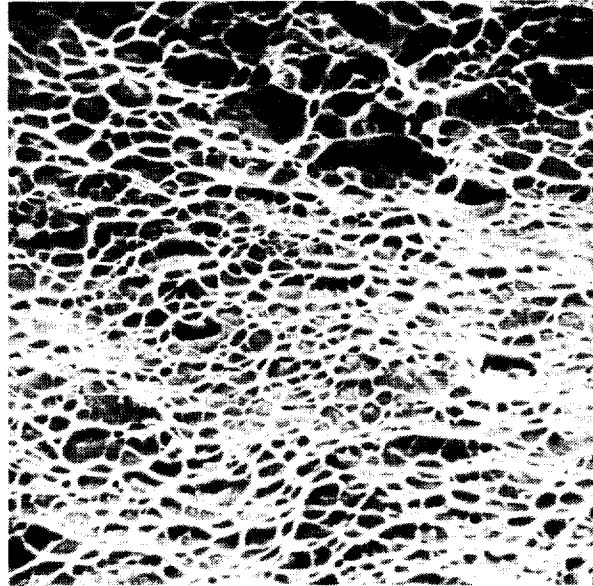
Fig 3-4  
Region A. Shear lip area. 640X.

Figure 3-4 to 3-5 Area A: This region is on a shear lip. Although the surface is relatively smooth, ductile rupture is evident in the form of shallow equiaxed dimples.

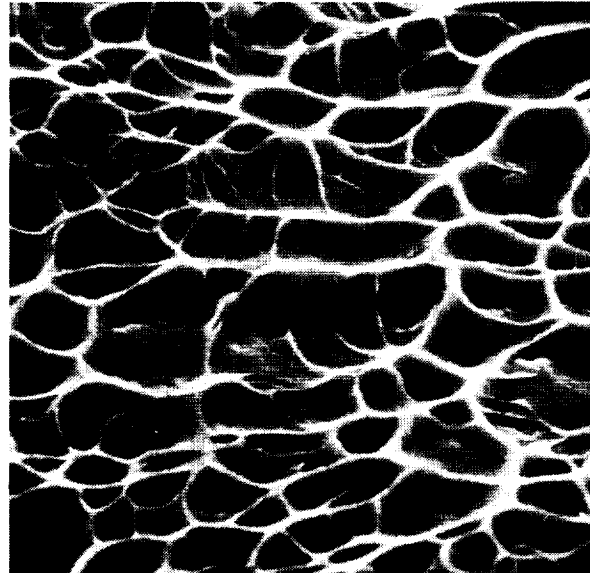
Fig 3-5  
Region A. Enlarged view of center of Fig. 3-4. 2500X

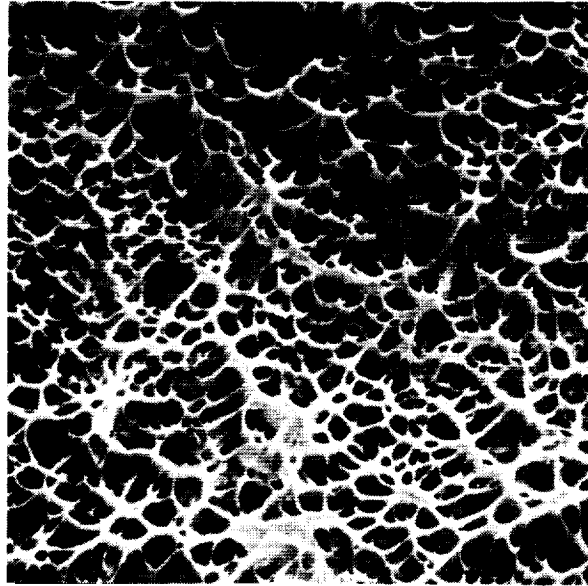
Fig 3-6  
Region B. Another shear area. 640X

Figures 3-6 to 3-7 Area B: Another shear lip. The ductile dimples are elongated and oriented in the same direction.

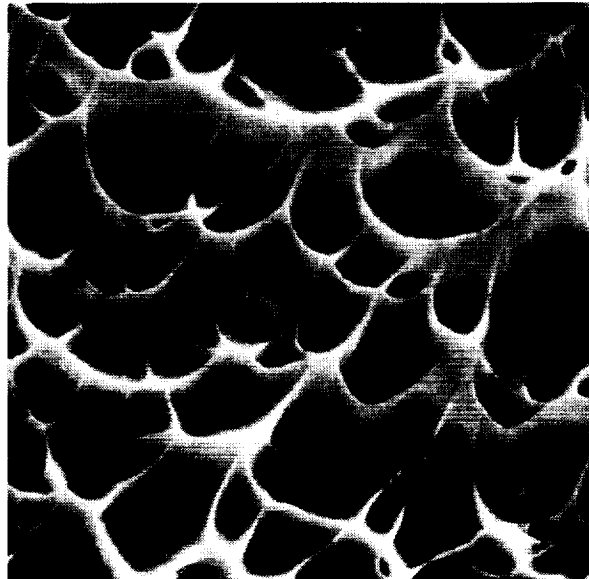
Fig 3-7  
Region B. Enlarged view of center of Fig. 3-6. 2500X

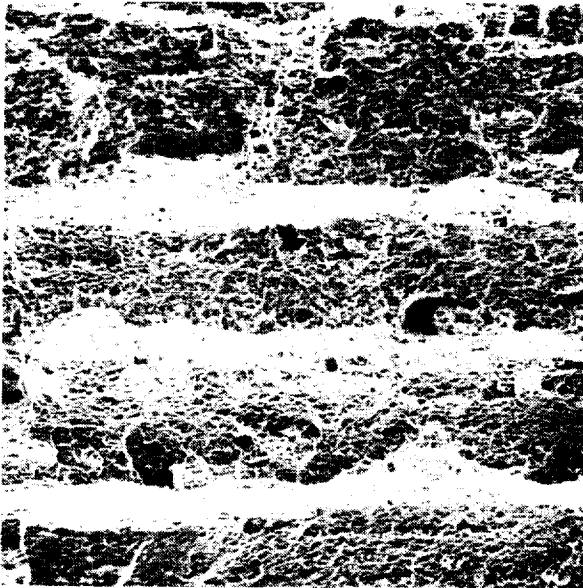
Fig 3-8  
Region C. Central region of fracture. 80X

Figures 3-8 to 3-11 Area C: This area is representative of the central region of the sample. Note the ridges associated with the grain structure. There are numerous ductile dimples.

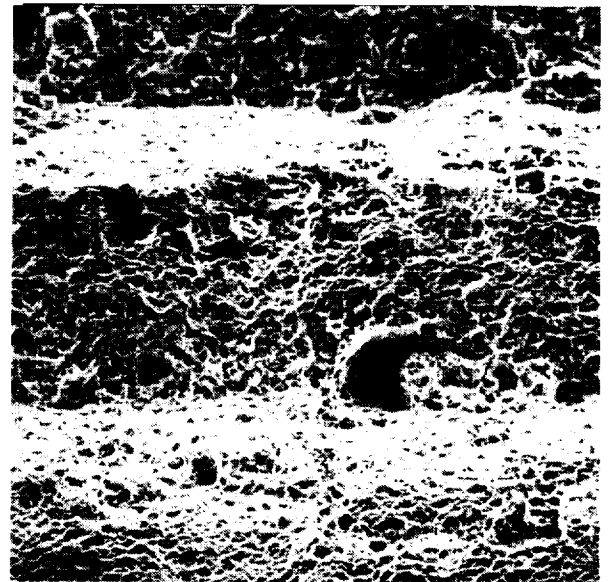
Fig 3-9  
Region C. Enlarged view of the central region of fracture. 160X

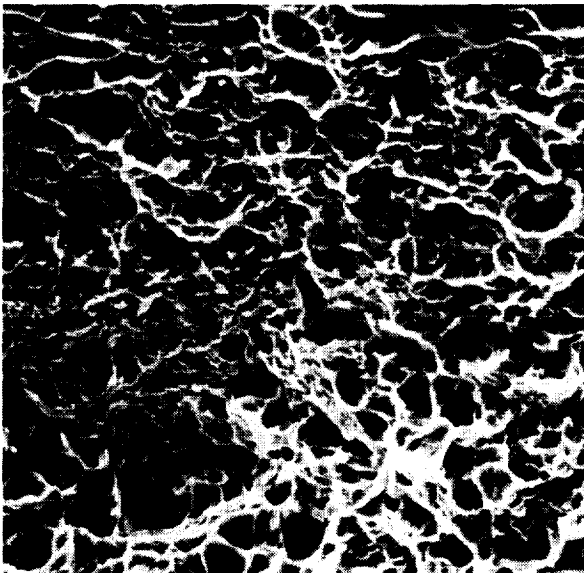
Fig 3-10  
Region C. Enlarged view of the center of Fig. 3-9. 640X

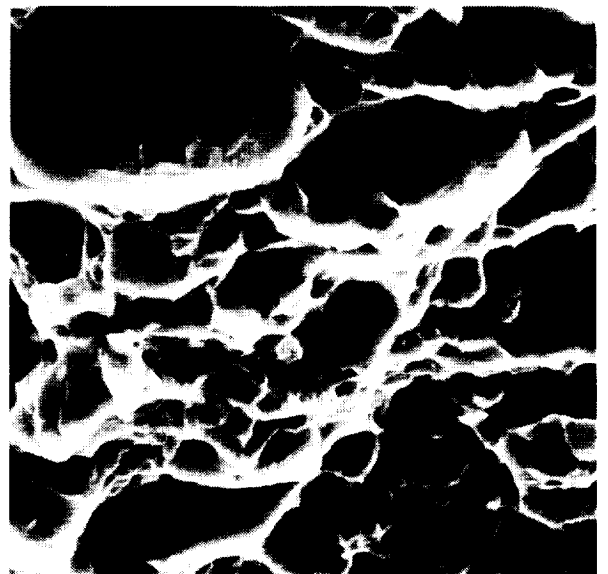
Fig 3-11  
Region C. Enlarged view of the center of Fig. 3-10. 2500X

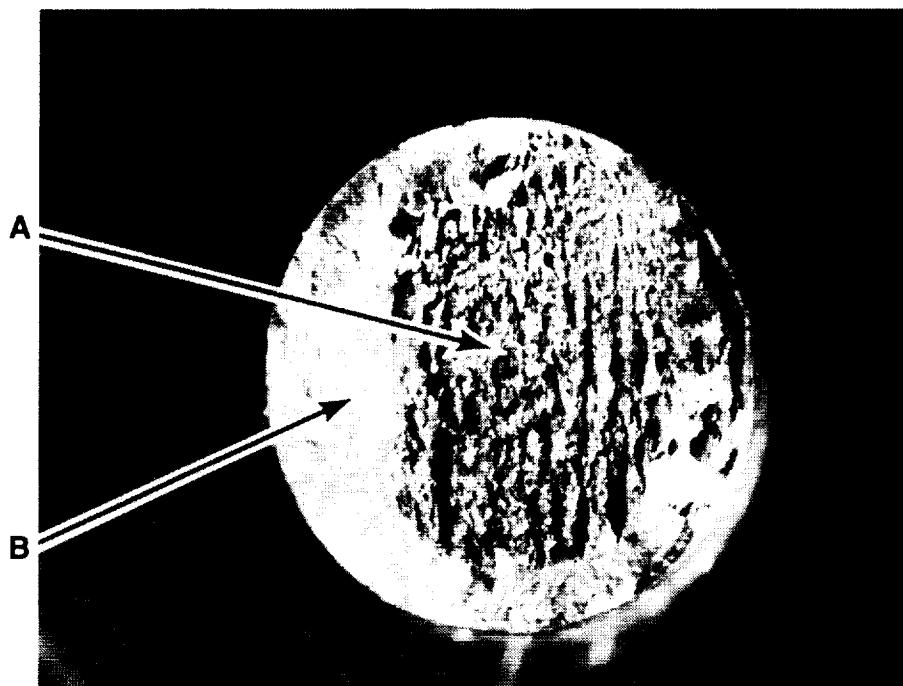
Fig 3-12  
Optical photomicrograph of fracture surface.

The macrofractograph of this fracture shown in Figure 3-12 displays a central region of rough surface with many small ridges oriented parallel to the rolling direction. The central region is surrounded by a circumferential shear region which exhibits a smoother texture.

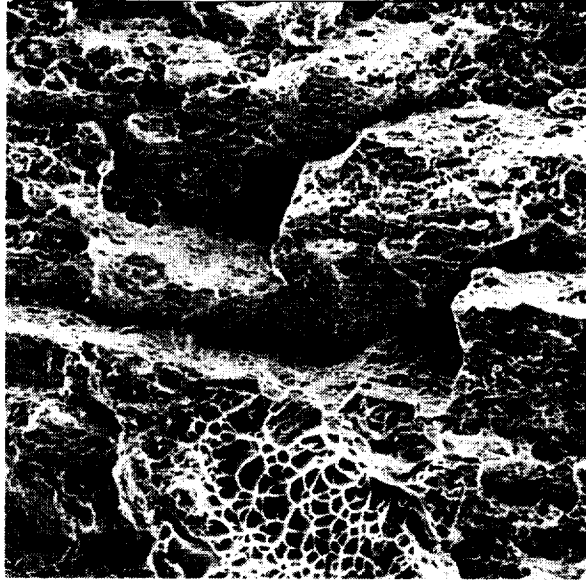
Fig 3-13 160X  
Region A. Central region of fracture.

Figures 3-13 to 3-16 Area A: This area is representative of the ductile overload found on most of the fracture surface. Notice that the fracture is more brittle than the room temperature sample. There is secondary cracking in this sample.

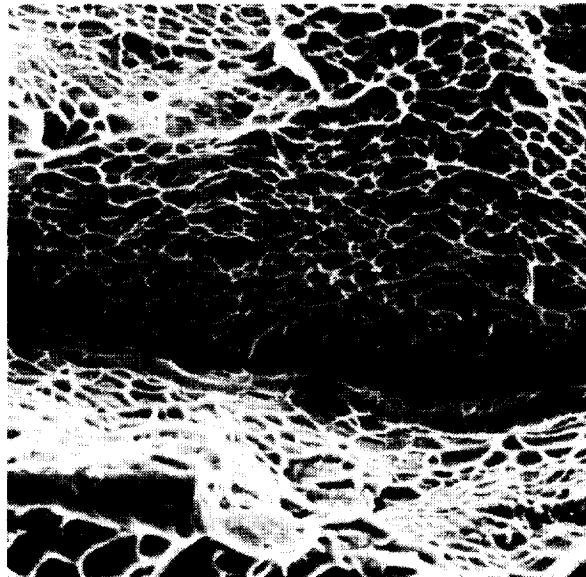
Fig 3-14 640X  
Region A. Enlarged view of Fig. 3-13.

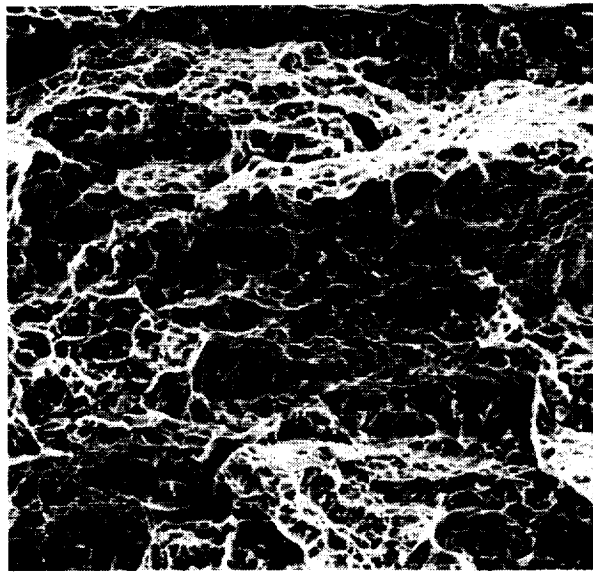
Fig 3-15 320X  
Region A. Another area in the central region  
of fracture.

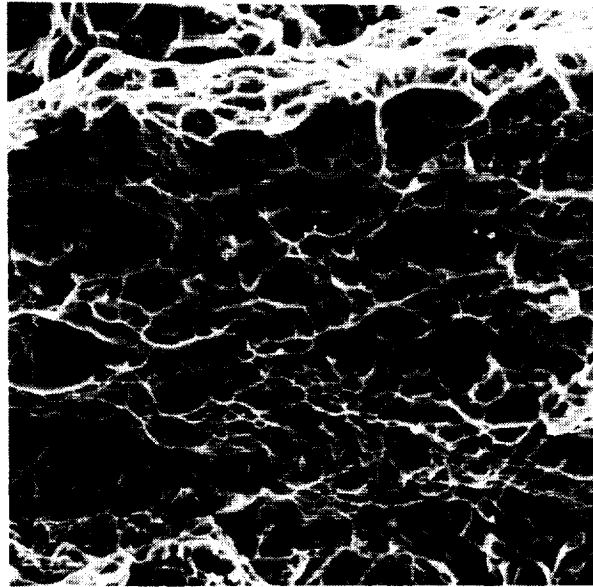
Fig 3-16 640X  
Region A. Enlarged view of Fig. 3-15.

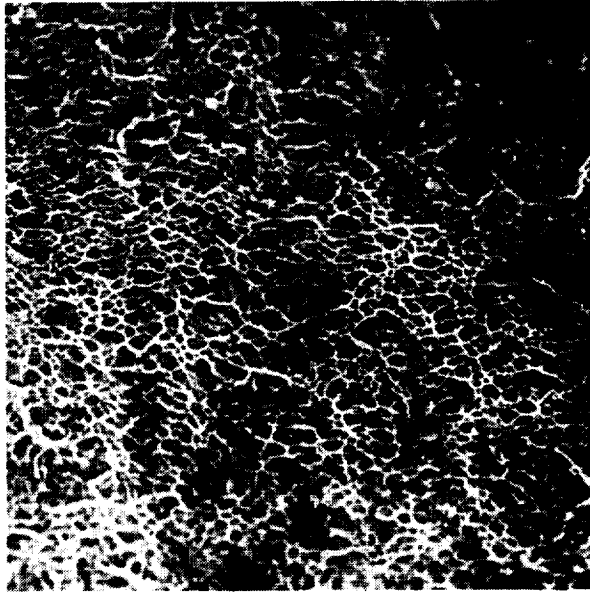
Fig 3-17 320X  
Region B. Shear lip area.

Figures 3-17 to 3-18 Area B: Fracture in this area is much like the fracture in the shear lip area of the room temperature sample. The dimples are shallower and smaller in size as compared to those in area A.

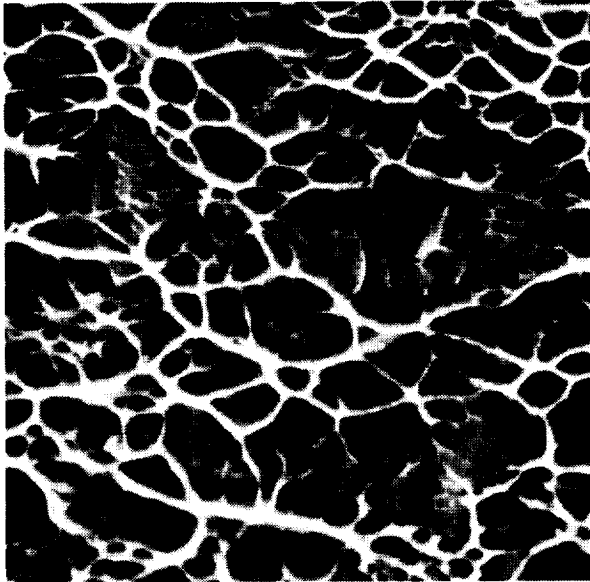
Fig 3-18 1250X  
Region B. Enlarged view of Fig. 3-17.

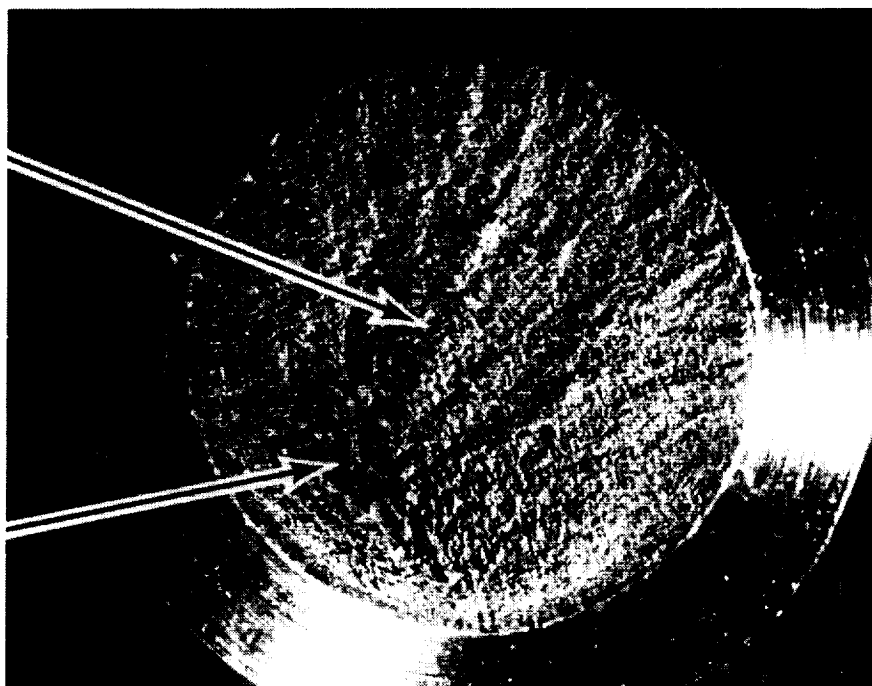
Fig 3-19  
Optical photomicrograph of fracture surface.

Figure 3-19 shows the macrofractograph of this sample. The appearance is smooth with a faint radial pattern generating from the fracture origin.

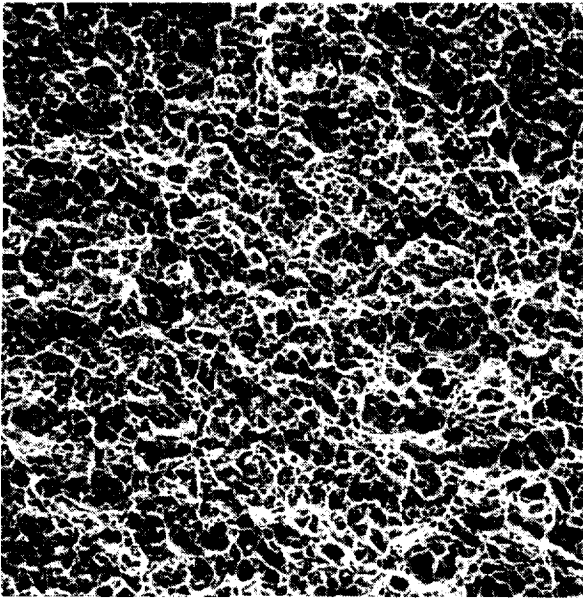
Fig 3-20 160X  
Region A. Central region of fracture.

Figures 3-20 to 3-23 Area A: These fractographs are typical of the morphology of the central part of the specimen. Dimple rupture is the predominant mode.

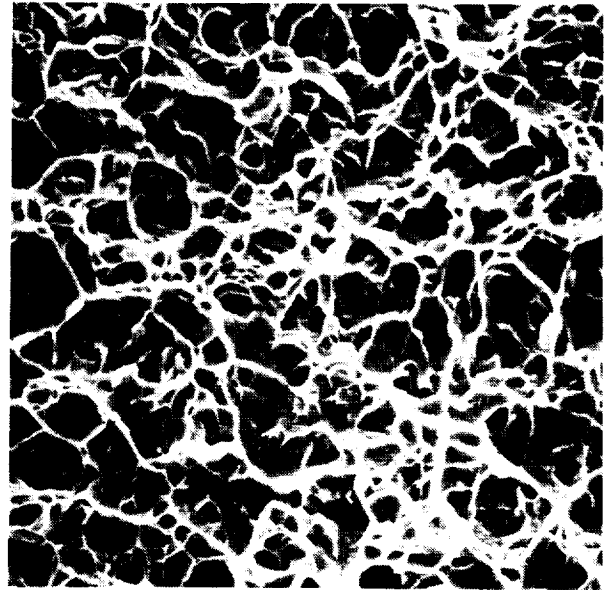
Fig 3-21 640X  
Region A. Enlarged view of Fig. 3-20.

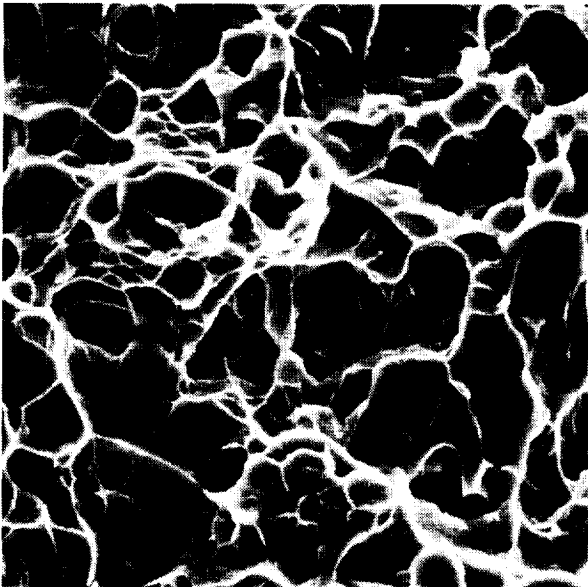
Fig 3-22 1250X  
Region A. Enlarged view of Fig. 3-21.

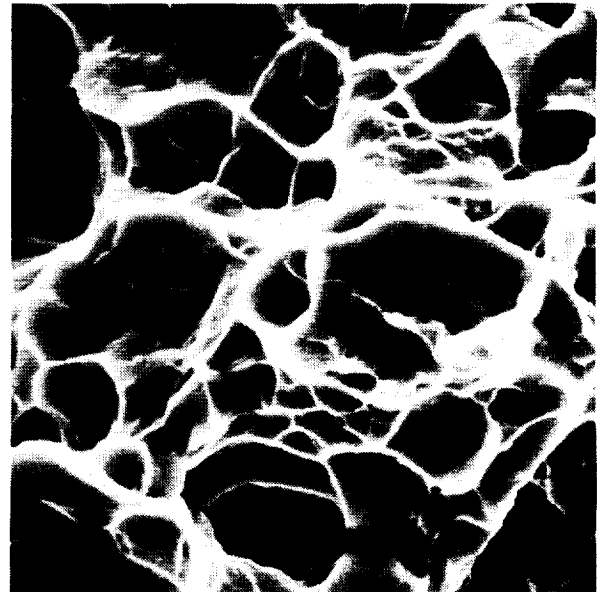
Fig 3-23 2500X  
Region A. Enlarged view of Fig. 3-22.

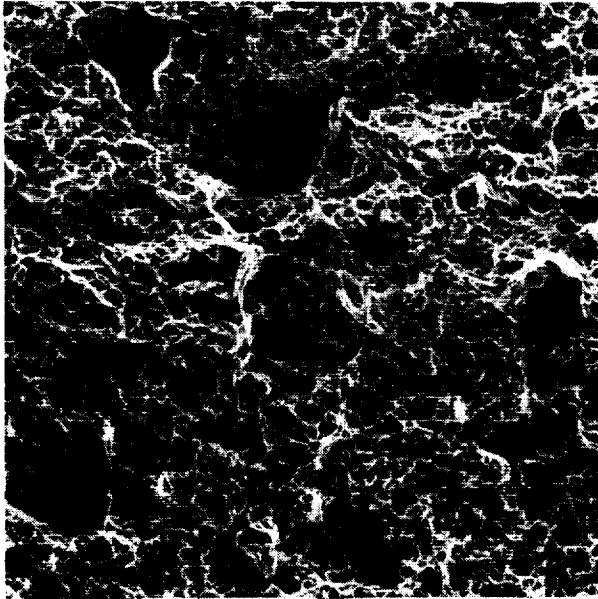
Fig 3-24 160X  
Region B. Area near the fracture origin.

Figures 3-24 to 3-27 Area B: This area is near the fracture origin. The fracture is rougher and shows evidence of ductile tearing and secondary cracking.

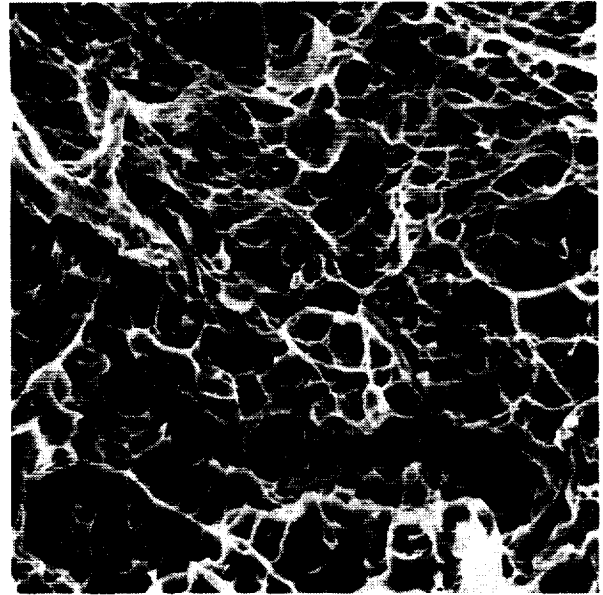
Fig 3-25 640X  
Region B. Enlarged view of Fig. 3-24.

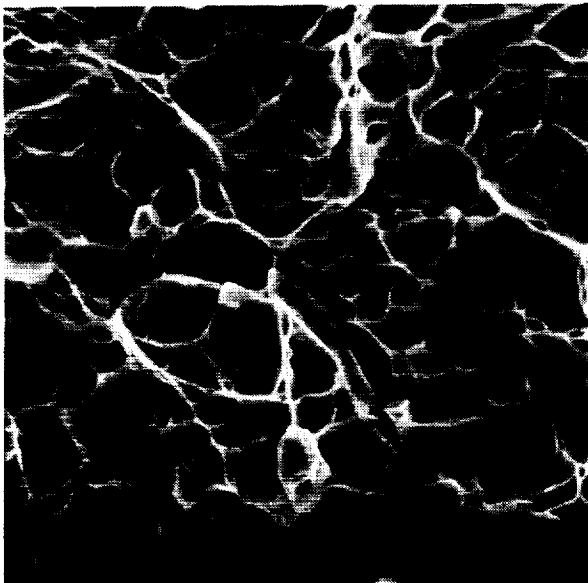
Fig 3-26 1250X  
Region B. Enlarged view of Fig. 3-25.

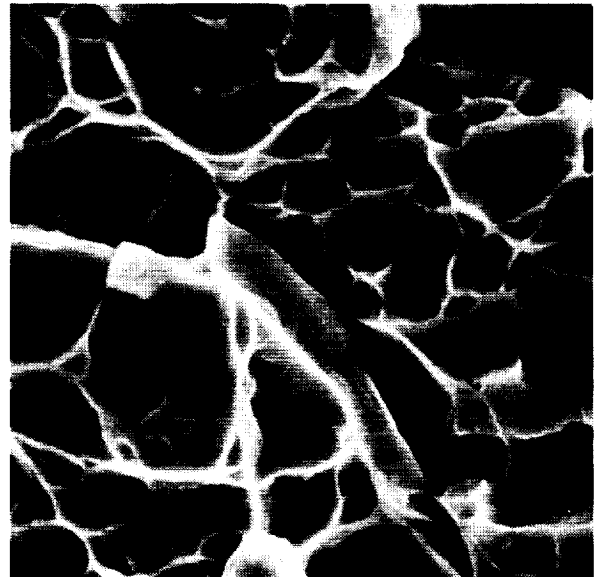
Fig 3-27 2500X  
Region B. Enlarged view of Fig. 3-26.

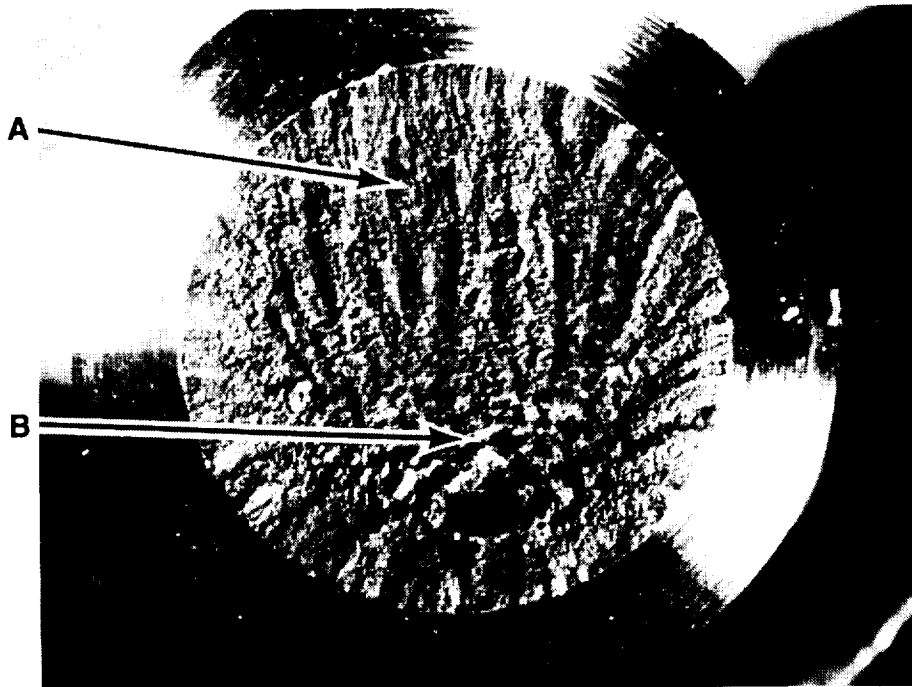
Fig 3-28  
Photomicrograph of fracture surface.

15X.

The macrofractograph of this fracture is shown in Figure 3-28. The surface is slightly rougher than the notched room temperature sample. The radial pattern originating from the fracture origin is also more pronounced.

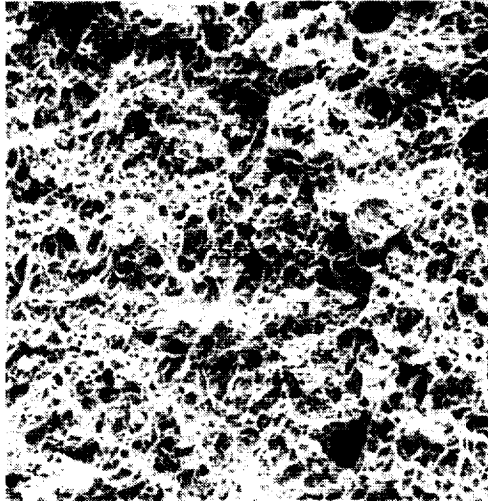
Fig 3-29 160X  
Region A. Central region of fracture.

Figures 3-29 to 3-31 Area A: These fractographs show the ductile rupture typical of the fracture. Note that there is less plasticity in this sample than in the room temperature notched sample as the dimples are less deep.

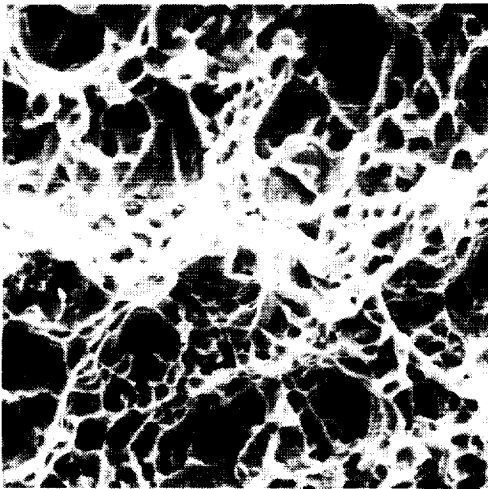
Fig 3-30 640X  
Region A. Enlarged view of Fig. 3-29.

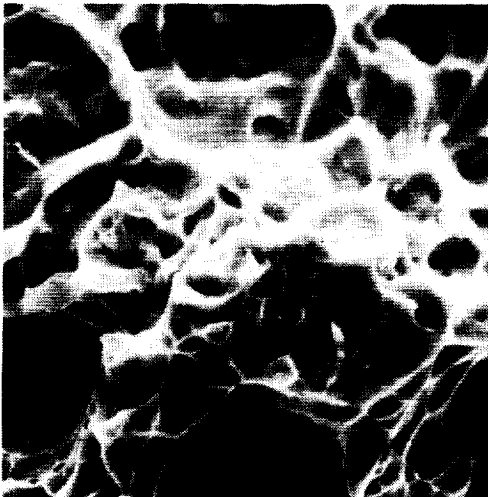
Fig 3-31 1250X  
Region A. Enlarged view of Fig. 3-30.

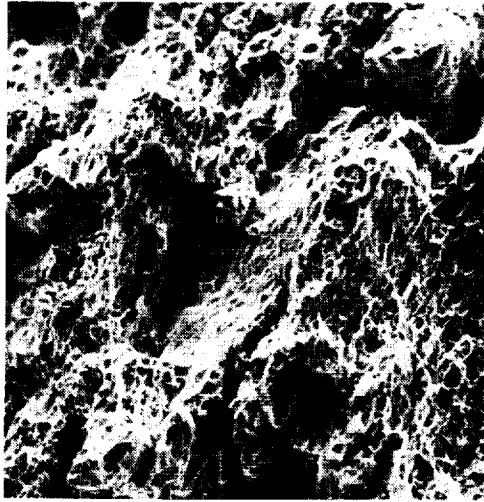
Fig 3-32 160X  
Region B. Region near the fracture origin.

Figures 3-32 to 3-34 Area B: This area is near the fracture origin. Note that there are signs of lessened ductility such as secondary cracking.

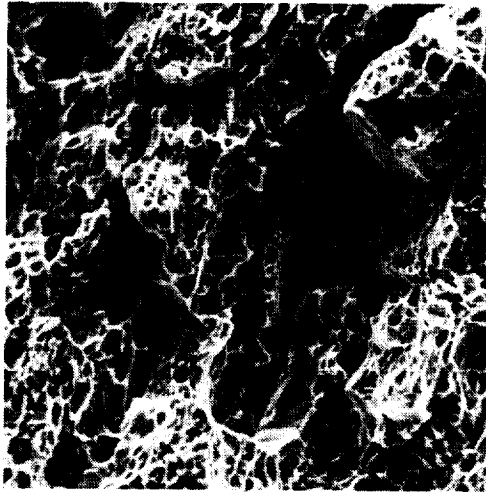
Fig 3-33 320X  
Region B. Enlarged view of Fig. 3-32.

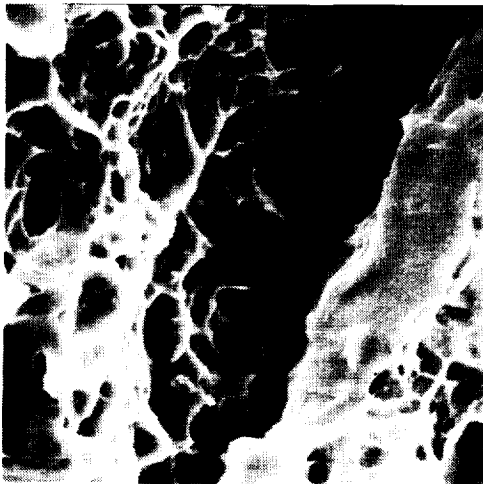
Fig 3-34 1250X  
Region B. Enlarged view of Fig. 3-33.

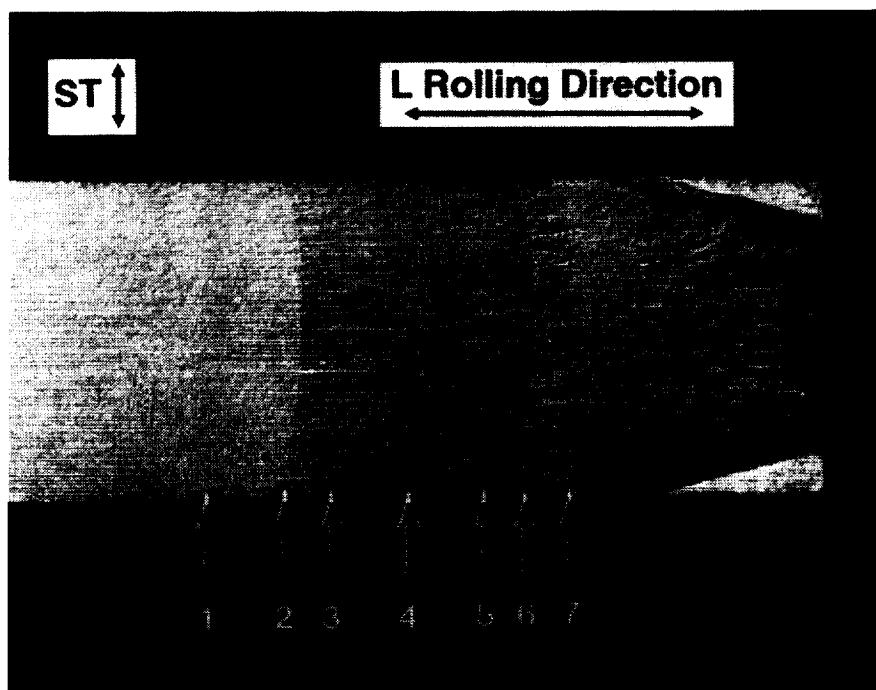
Fig. 3-35  
Optical photomicrograph of fatigue fracture surface.

4X

Seven fatigue regions are shown in the optical photograph in Figure 3-35. Fatigue fracture Regions 2 through 6 were documented with fractographs. Region 1 and region 7 are the precrack and final fast fracture regions respectively, and they were not documented. The data depicting the test conditions used to grow the crack in Regions 2 through 6 is presented in the chart below, where R represents the ratio of the minimum to maximum load and  $K_{max}$  is the maximum stress concentration at the crack tip.

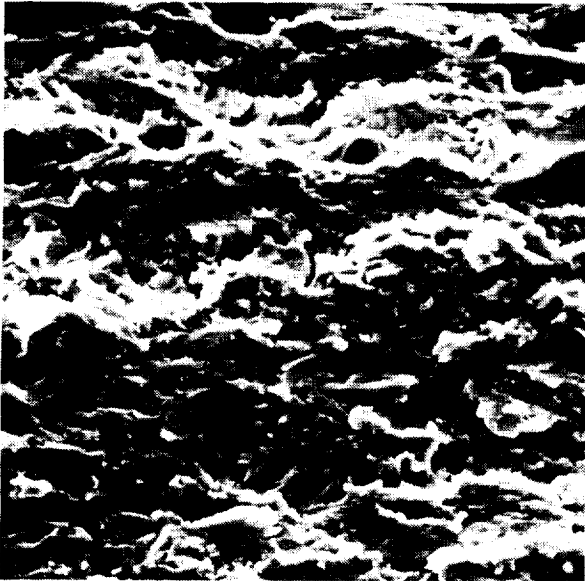
Fig. 3-36  
Region 2. Faint fatigue striations. 640X

Figures 3-36 to 3-39 Region 2: The striations are difficult to find even at 10,000X with these load parameters.

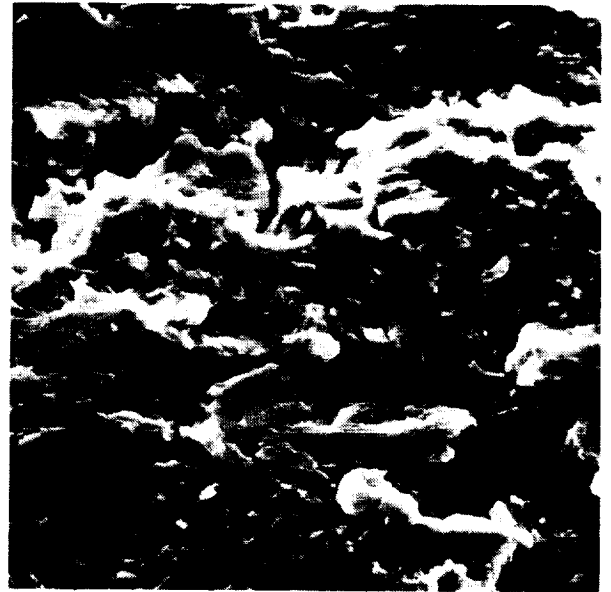
Fig. 3-37  
Region 2. 1250X

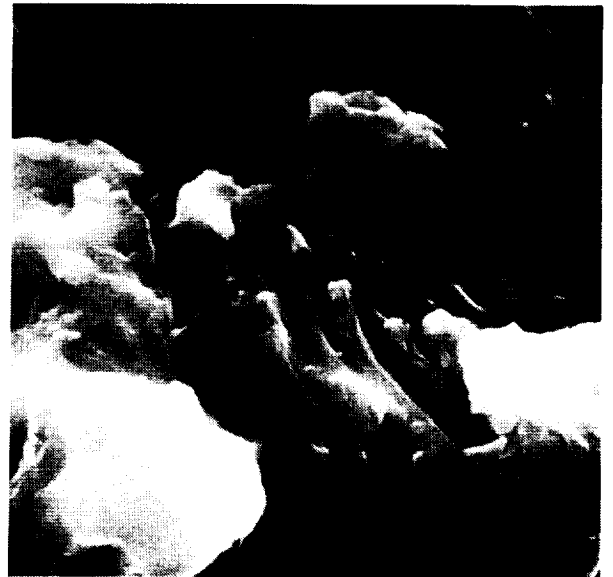
Fig. 3-39  
Region 2. 10000X

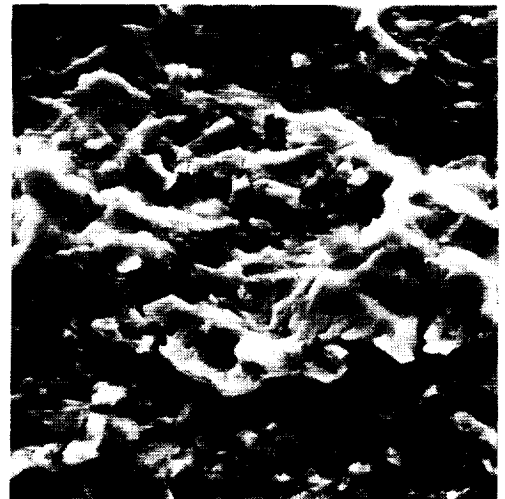
Fig. 3-41 1250X  
Region 3.

Figures 3-40 to 3-44 Region 3: Striations are more evident as a smaller load ratio is applied.
